# Weak Plane Failure of Phyllitic Sandstone: Slope Stabilization of the Access Road of Mae Mao Dam

Suttisak Soralump, Rattatam Isaroranit, Bunpoat Kulsuwan & Sirisart Yangsanphu, 2010. Weak Plane Failure of Phyllitic Sandstone: Slope Stabilization of the Access Road of Mae Mao Dam. International Conference on Slope 2010 : Geotechnique and Geosynthetics for Slopes, 27-30 July, 2010 Chiangmai, Thailand. organized by the Department of Highways, Thailand (DOH)

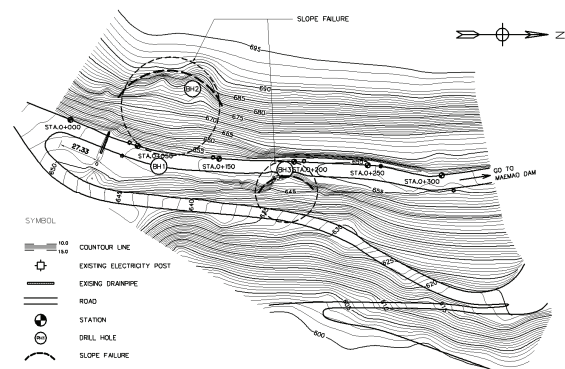
Figure 1: Topographic of the failure area.

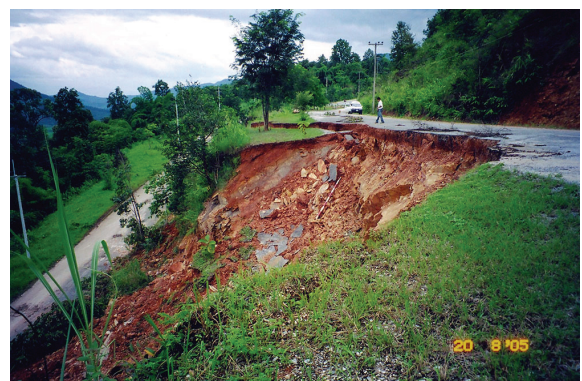
Mae Mao hydropower project located at Fang district, Chiangmai province. The general geology consists of Phyllitic sandstone and Quartzitic sandstone. After 24 years of construction (since 1986) the failure of the main access road to the dam has occurred (Figures 1 and 2). The factor causing the failure is unclear, two possibilities have been suspected rainfall and seismic. At the day of failure the precipitation record was just 2mm and the 4 days accumulated record prior to the failure was just 59.2mm (Figure 3). Regarding to the precipitation records that causing the landslide in the country, the precipitation recorded found seems to be not enough to cause the failure. Another possibility might be credited to the seismic activities around the site which quite active during the past service period of the dam (Figure 4). With the evident of the seismic activities in the area, the seismic deformation occur in the slope could be accumulated to eventually causing the slope failure. Anyhow, this paper is not intended to investigate the exact cause of the failure. The investigation is limited just enough for safely repair the failed slope.

Figure 2: Failure of the access road.

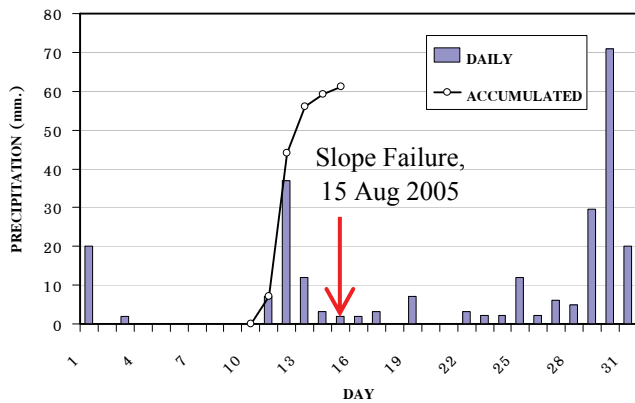
Figure 3: Daily rainfall record in August 2005 (Mae Mao Hydropower Project, 2006).

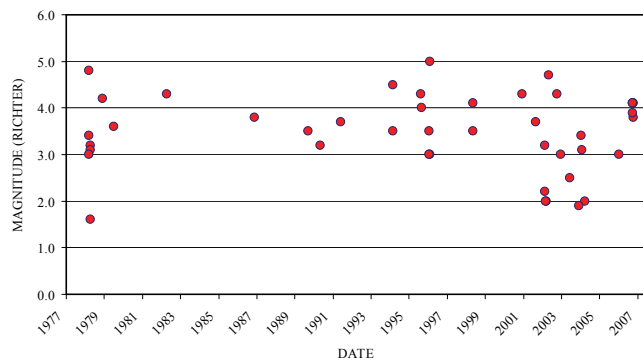
Figure 4: Seismic record (Magnitude) from 1978 to 2007 (The Meteorological Department, 2006).

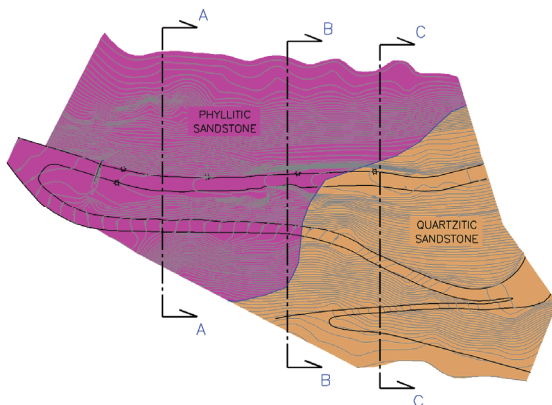
Geological investigation was done and found that the 15-35 meter thick of Phyllitic sandstone is overlain the Quartzitic sandstone. Figure 5 is the plan view show the rock contact boundary. Combining with the boring log data, the schematic of geologic structure can be shown in Figure 6. The rock structures consist of fault, shear and foliation. It's the foliation plane that firstly suspected to be the plane of failure. The orientation of this foliation plane consists of strike and dip angle of 330/30. Figures 7 and 8 show the picture of fractures and planes. Figure 9 shows the analysis of Stereonet (Markland, 1972).

Figure 5: Plan view showing the contact zone.

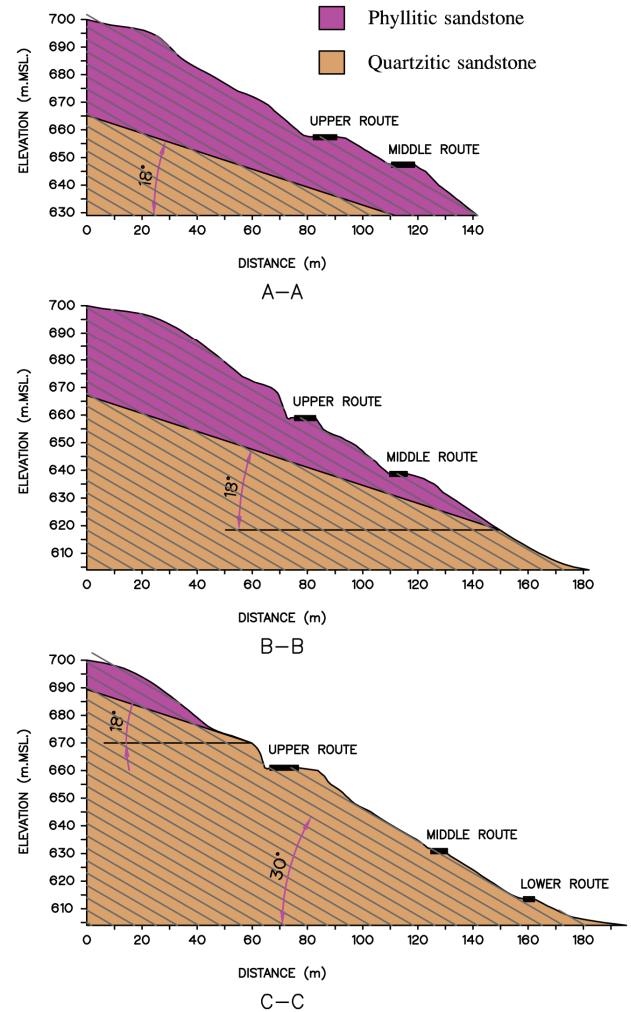
Figure 6: Cross sections and geologic structure.

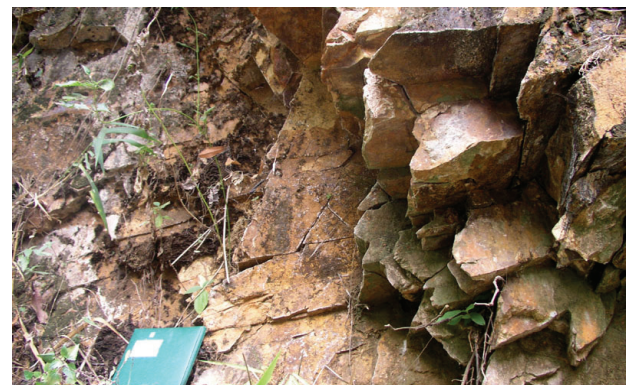
Figure 7: Rock fractures.

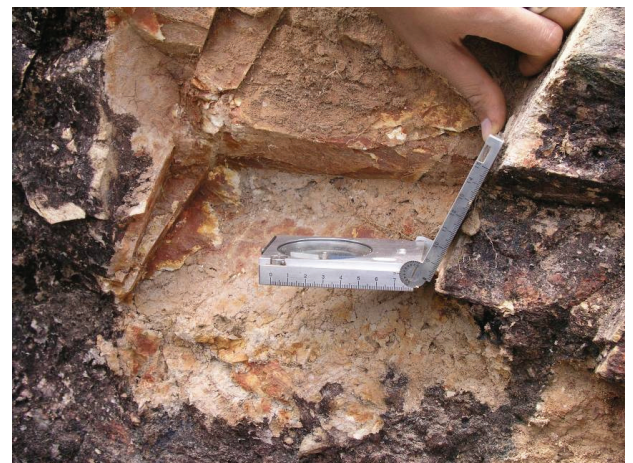
Figure 8: Fracture planes.

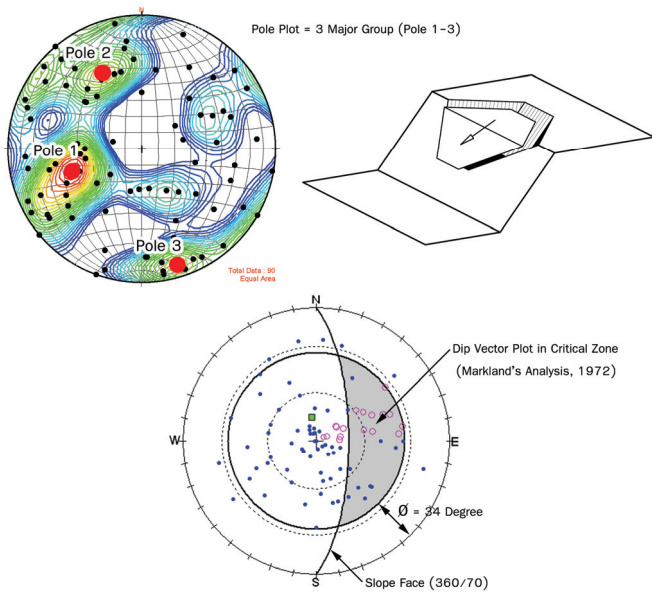
Figure 9: Stereonet analysis.

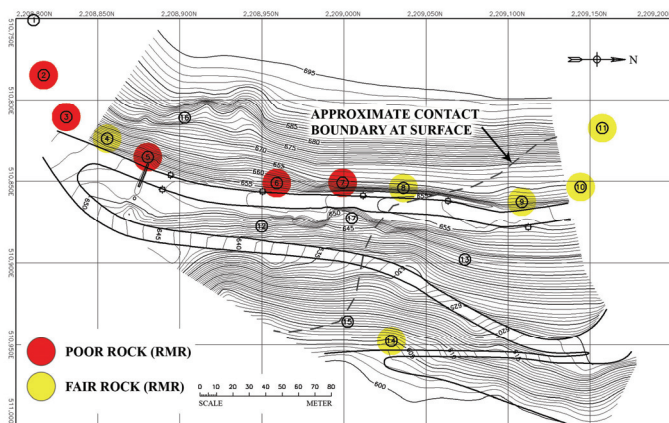
3.1 RMR (Bieniawski, 1973) and SMR (Romana, 1985) determination of the rock mass in the area vicinity to the failure were done . The results are shown in Fig 10 and 11. It was found that the Phyllitic sandstone is mostly classified as poor to bad rock while the Quartzitic sandstone is classified as normal to good and fair rock.

Figure 10: Rock mass quality determination by RMR.

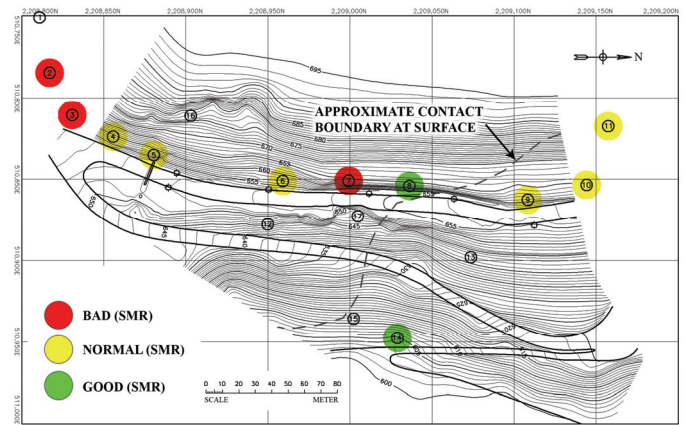
Figure 11: Slope mass quality by SMR.

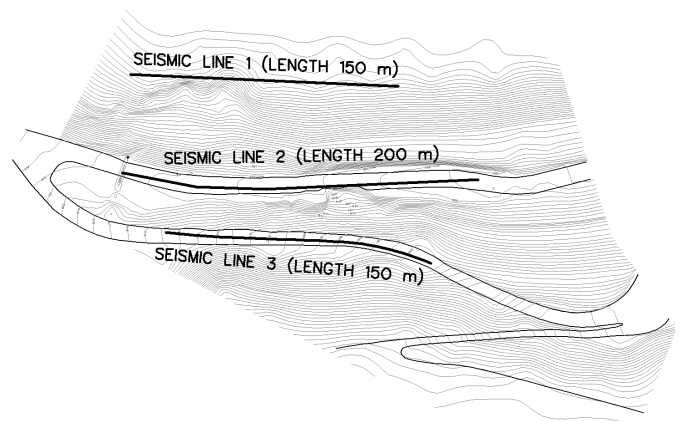
3.2 Seismic refraction survey (Hagiwara and Omoto ,1939) was done in order to investigate the thickness of weak strata. The results found that, at the lower portion of the hill (line 3), rock mass presents less density than the upper portion (line 1) (Figures 12 and 13). This information is very useful in making the decision of repairing method.

Figure 12: Seismic refraction surveying lines.

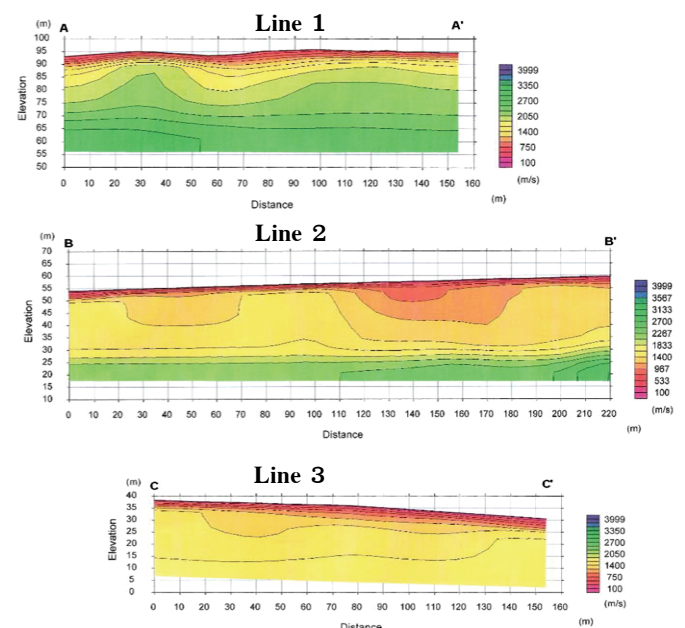
Figure 13: Result of seismic refraction survey.

4.2 The concept of increasing resisting force by counter weight berm in the toe of cut slope and use the upper portion of the hill is omitted in order to prevent the progressive failure since the rock mass in the lower portion was found to be in higher weathering degree. This is according to the result of seismic refraction and visual geological survey.

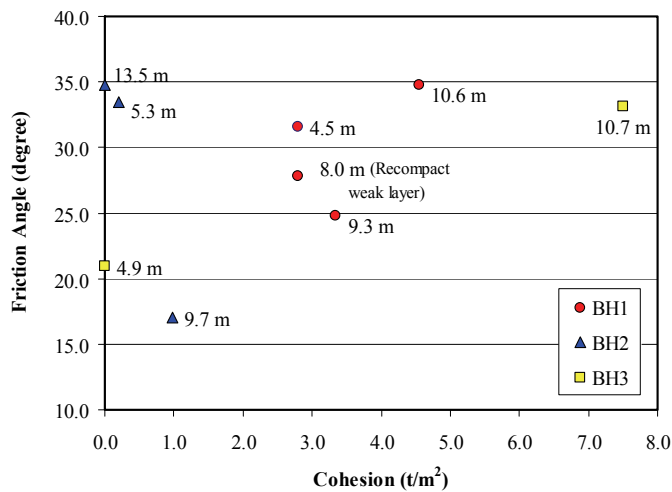
3.3 Three NX-size boreholes by rock coring were done to the depth of between 10- 20 meter. One borehole (BH-1) was drilled at the right angle to the suspected major sliding plane (dip angle of 30 degree). Part of the results is shown in Figures 14 and 15. The results from three boreholes reveal that there is a 3 meter thick weak layer found as shown in Figure 16. This weak layer has a dip angle quite similar to the dip angle of the foliation plane described earlier. Decomposed material in the weak layer was collected and recompacted to the estimated undisturbed state density and water content to prepare the reconstitute sample for direct shear test. Slow shearing rate was used to obtain the effective strength parameters of the weak layer material. The joint strength of Phyllitic sandstone mass was tested using the direct shear machine to obtain shear strength parameters of the natural joint and also saw cut joint (ASTM, 2002.). The total of 9 samples were performed and the results are shown in Table 1 and Figure 17.

Figure 17: Result of direct shear test.

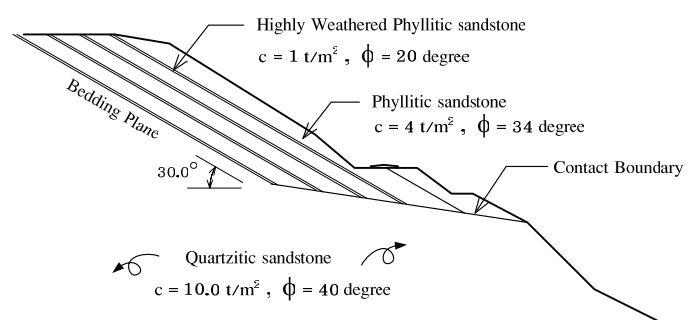
5.1 Back analysis was done with configuration as shown in Figure 18. The 5 meter thick layer of Phyllitic sandstone is modeled together with the 0.5 meter thick of weak layer in which all layers have 30 degree of dip angle. The results of direct shear test explained earlier were used. The Phyllitic sandstone strength parameters are modeled based on its joint strength. The weak layer shear strength is modeled based on the direct shear test result of recompacted material. The result found that the thickness of rock mass layer has to be at least 10 meter thick in order to make the factor of safety of slope less than unity (Figure 19). This back analysis scheme is based on the assumption that the ground water located at the ground surface. The result of the back analysis corresponds with the actual condition where the weak layer is found at the depth 10 meter with almost 30 degree dip angle.

Figure 18: Configuration and properties of slope for back analysis case (Section A-A).

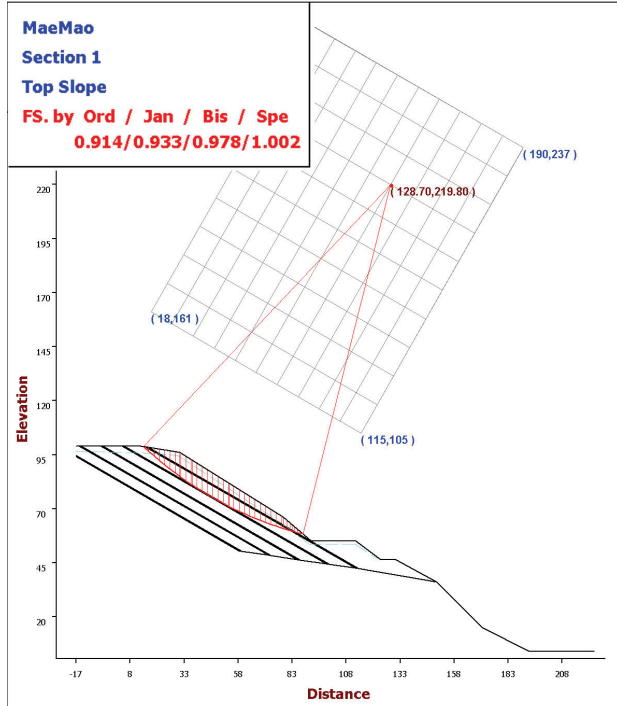
Figure 19: Result of slope stability analysis.

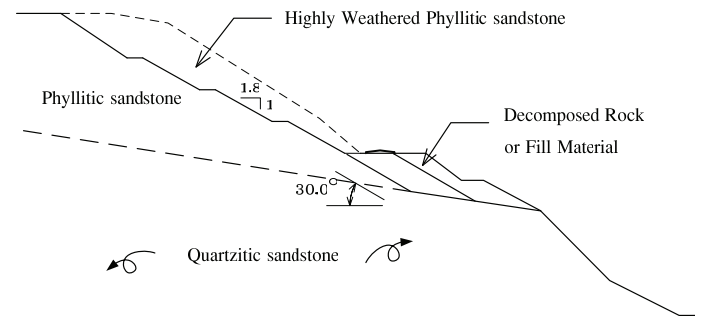
Figure 20: Configuration of remedial work (Section A-A).

5.2 Analysis for slope remedial design was done based on the design concept explained earlier. The Upper portion slope is designed to be flattening to 30 to 38 degree with 5 meter wide benching steps, 10-12 meter long rock nails and horizontal drains are used as shown in Figure 20. The design cases are shown in Table 3. The ground water level is assumed to be at the ground surface and the horizontal seismic coefficient is used to be equal to 0.05g. The target factor of safety of 1.5 is used. The results of all design cases are shown in Table 4. As for
