# Weak Plane Failure of Phyllitic Sandstone: Slope Stabilization of the Access Road of Mae Mao Dam

Suttisak Soralump, Rattatam Isaroranit, Bunpoat Kulsuwan & Sirisart Yangsanphu, 2010. Weak Plane Failure of Phyllitic Sandstone: Slope Stabilization of the Access Road of Mae Mao Dam. International Conference on Slope 2010 : Geotechnique and Geosynthetics for Slopes, 27-30 July, 2010 Chiangmai, Thailand. organized by the Department of Highways, Thailand (DOH)

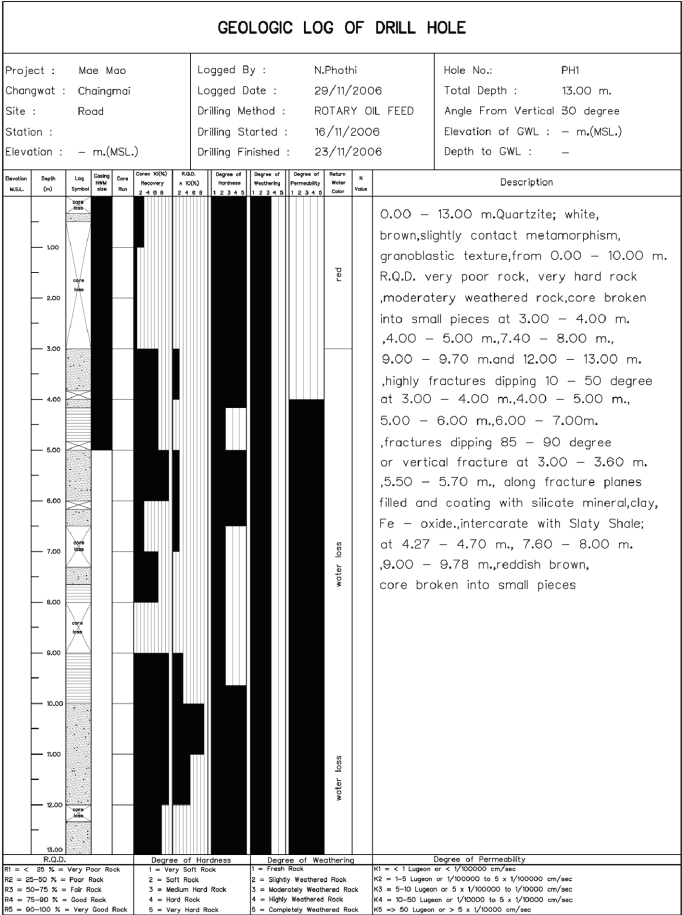
3.3 Three NX-size boreholes by rock coring were done to the depth of between 10- 20 meter. One borehole (BH-1) was drilled at the right angle to the suspected major sliding plane (dip angle of 30 degree). Part of the results is shown in Figures 14 and 15. The results from three boreholes reveal that there is a 3 meter thick weak layer found as shown in Figure 16. This weak layer has a dip angle quite similar to the dip angle of the foliation plane described earlier. Decomposed material in the weak layer was collected and recompacted to the estimated undisturbed state density and water content to prepare the reconstitute sample for direct shear test. Slow shearing rate was used to obtain the effective strength parameters of the weak layer material. The joint strength of Phyllitic sandstone mass was tested using the direct shear machine to obtain shear strength parameters of the natural joint and also saw cut joint (ASTM, 2002.). The total of 9 samples were performed and the results are shown in Table 1 and Figure 17.
